Texas Instruments, Attleboro, MA NPDES Permit

June 2020 conference call with EPA

3.) Summary of Exceedance of TCE Permit Limit at Outfall 002A

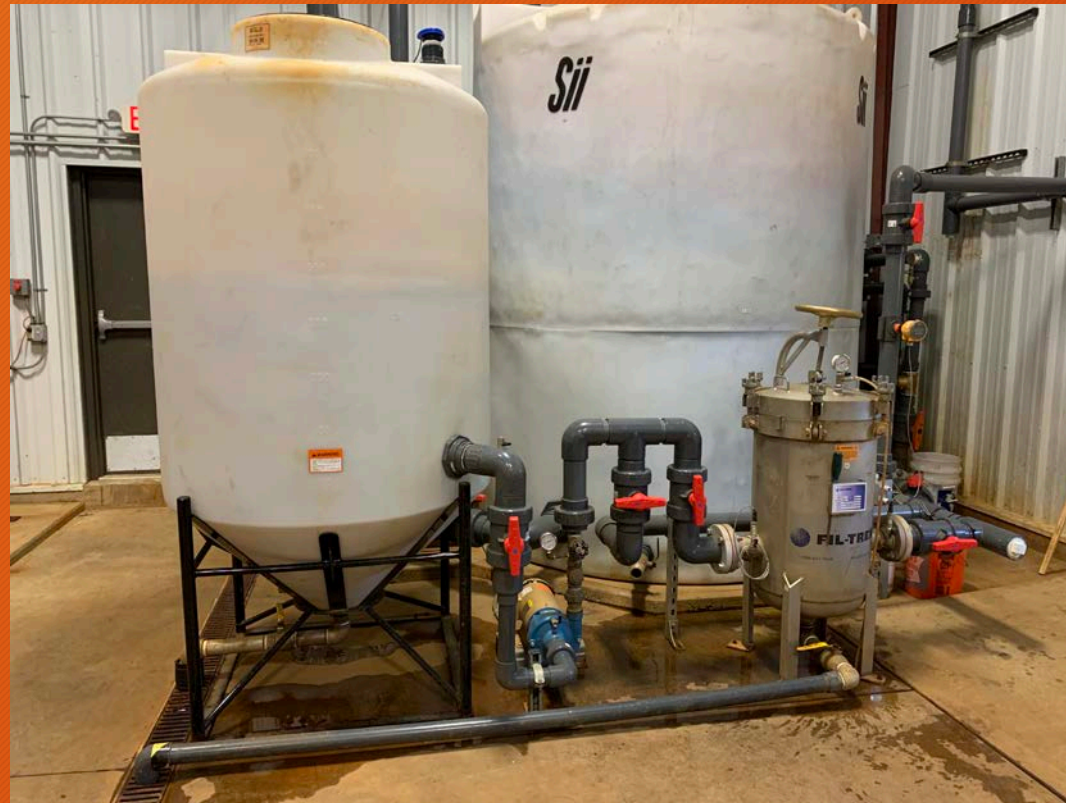
Stormwater Pre-Filtration System

- Corrective Actions Implemented since 2014:
 - Downstream drain cleaning to remove clog (2014);
 - Stormwater influent line cleaning with acid wash (2014, 2015);
 - Float switch and pump repairs/replacements (2016 - 2020);
 - Catch basin bottom sealings (2017);
 - Addition of pre-filtration of dry-weather flow (2018);
 - Replacement of CB-88 (2019);
 - Adjustment of overburden and storm sewer systems recovery flow rates (2017 - 2020);
 - Adjustments of level setpoints to ensure complete capture of dry-weather flow (2018 - 2020); and,
 - Cleaned effluent discharge pipe (2018 - 2020).

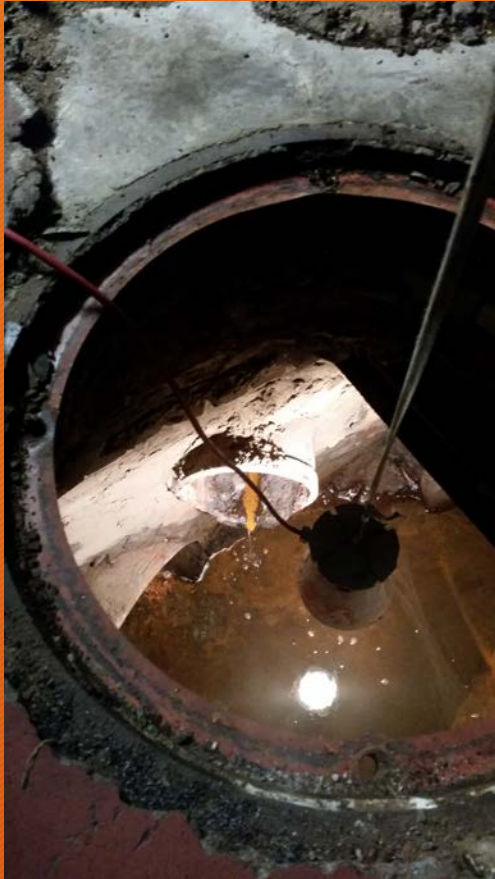
Pre-Sealing

Catch Basin Sealing (DMH-D in Building 3)

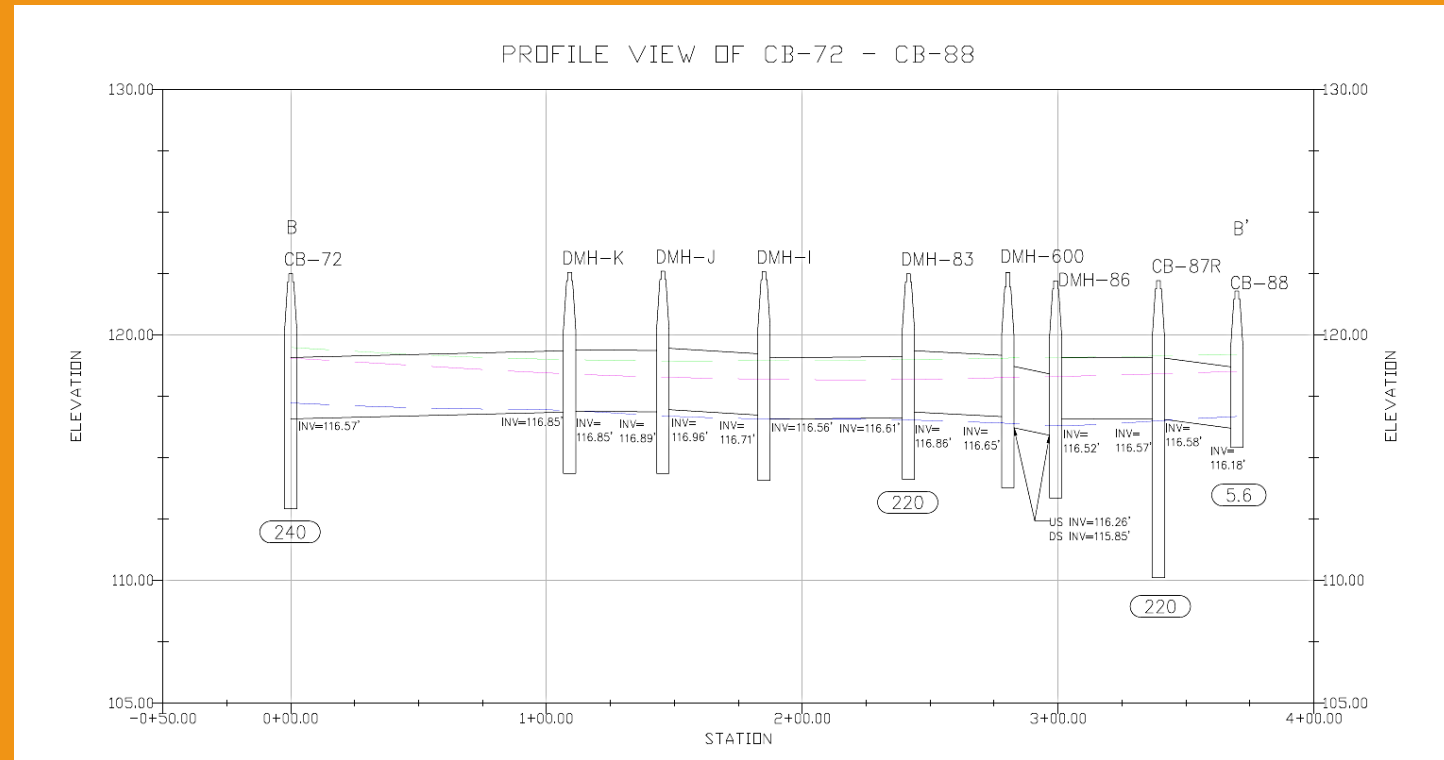
Example Storm Sewer Profile from 2019 Study

(depicting elevations, water levels
and TCE results)

- Storm sewer line (DMH-F) cleanout - June 2020.
- Catch basin sealing effectiveness testing - June/July 2020.
- Flow measurement work - on-going (continuation from 2019 studies):
 - Investigating groundwater infiltration to the subsurface storm water drainage system in the vicinity of the recovery and treatment system, to identify potential sources of significant infiltration, and to develop a strategy for improving the combined storm and groundwater recovery and treatment system efficiency.
- Overburden recovery system header pipe cleanouts - June/July 2020.
